# HD Bolts Installation & Inspection Procedure

Enhancing Access, Safety & Efficiency  
in High-Rise Building Maintenance

# Recommended Plinth Detail

The document details the recommended concrete plinth detail, installation sequence and inspection regime. If procedure within this document is followed, then the LOLER Inspector has a reduced requirement to internally inspect the plinths in future.

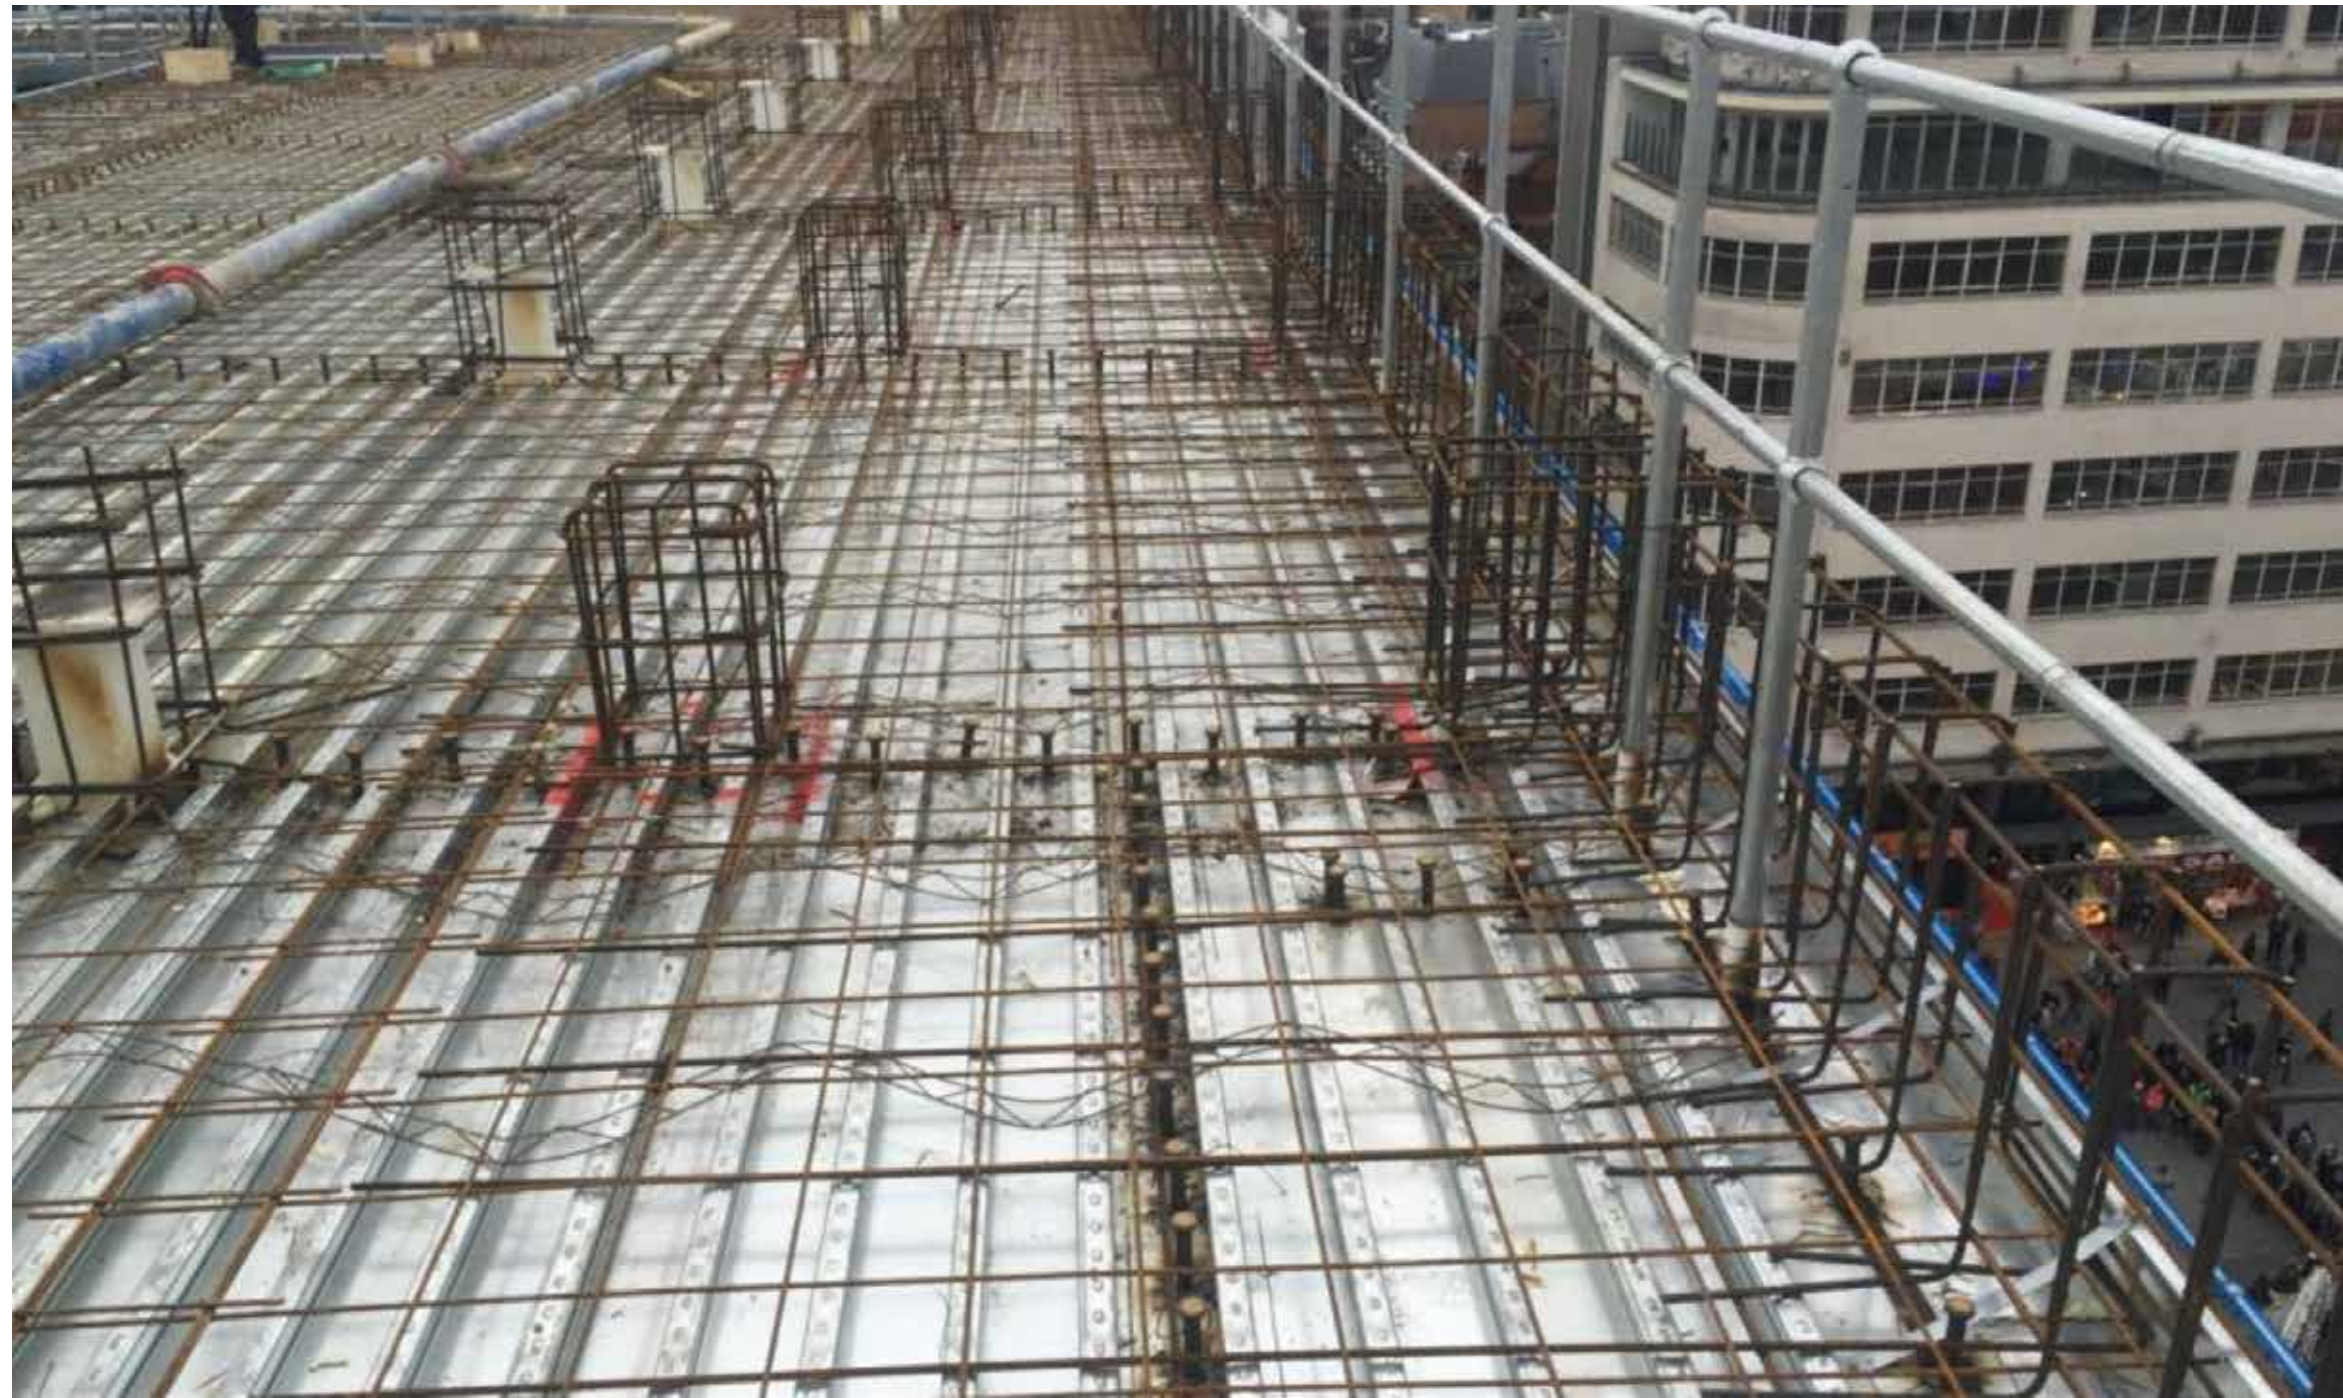
LOLER Inspection carried out

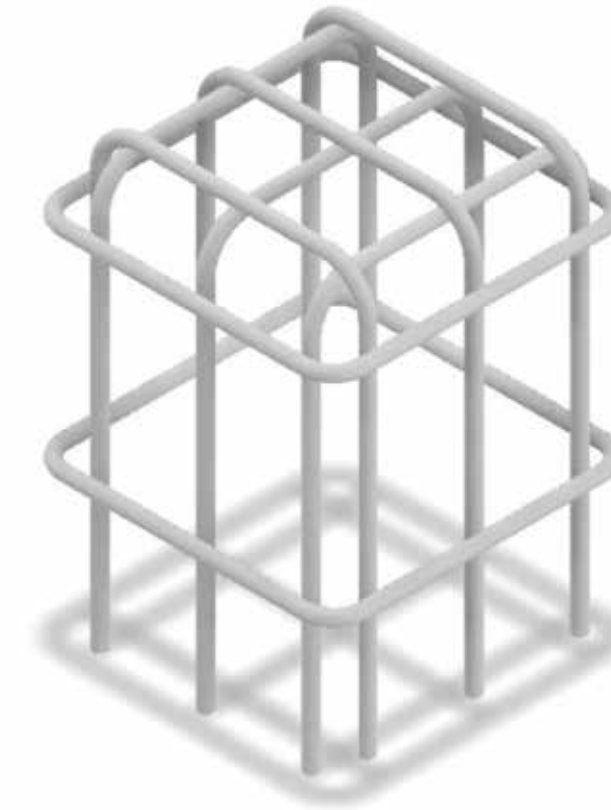
Main slab poured with typical formed upstand starter bars showing

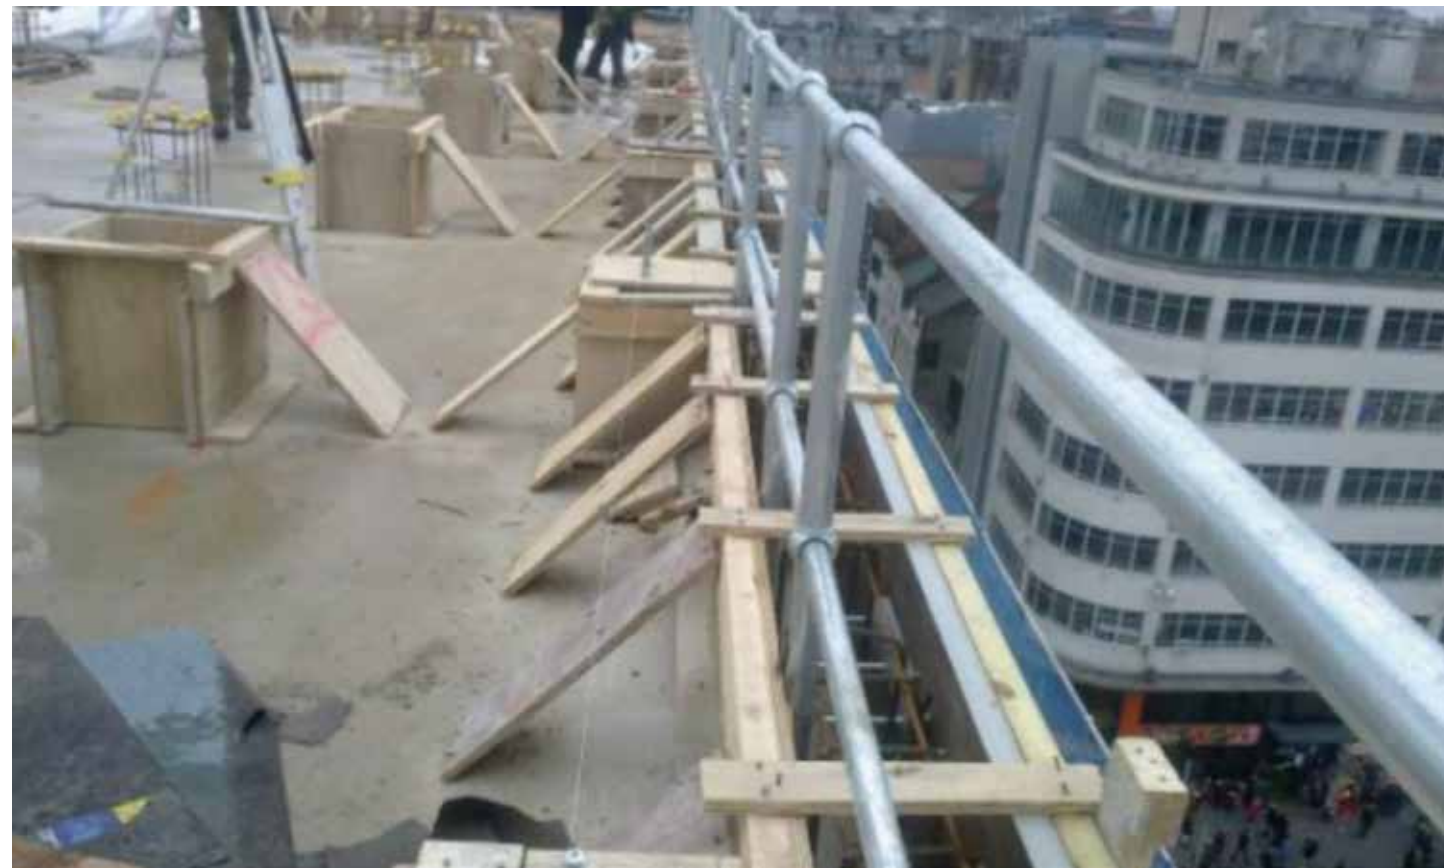
Alignment checked before pouring

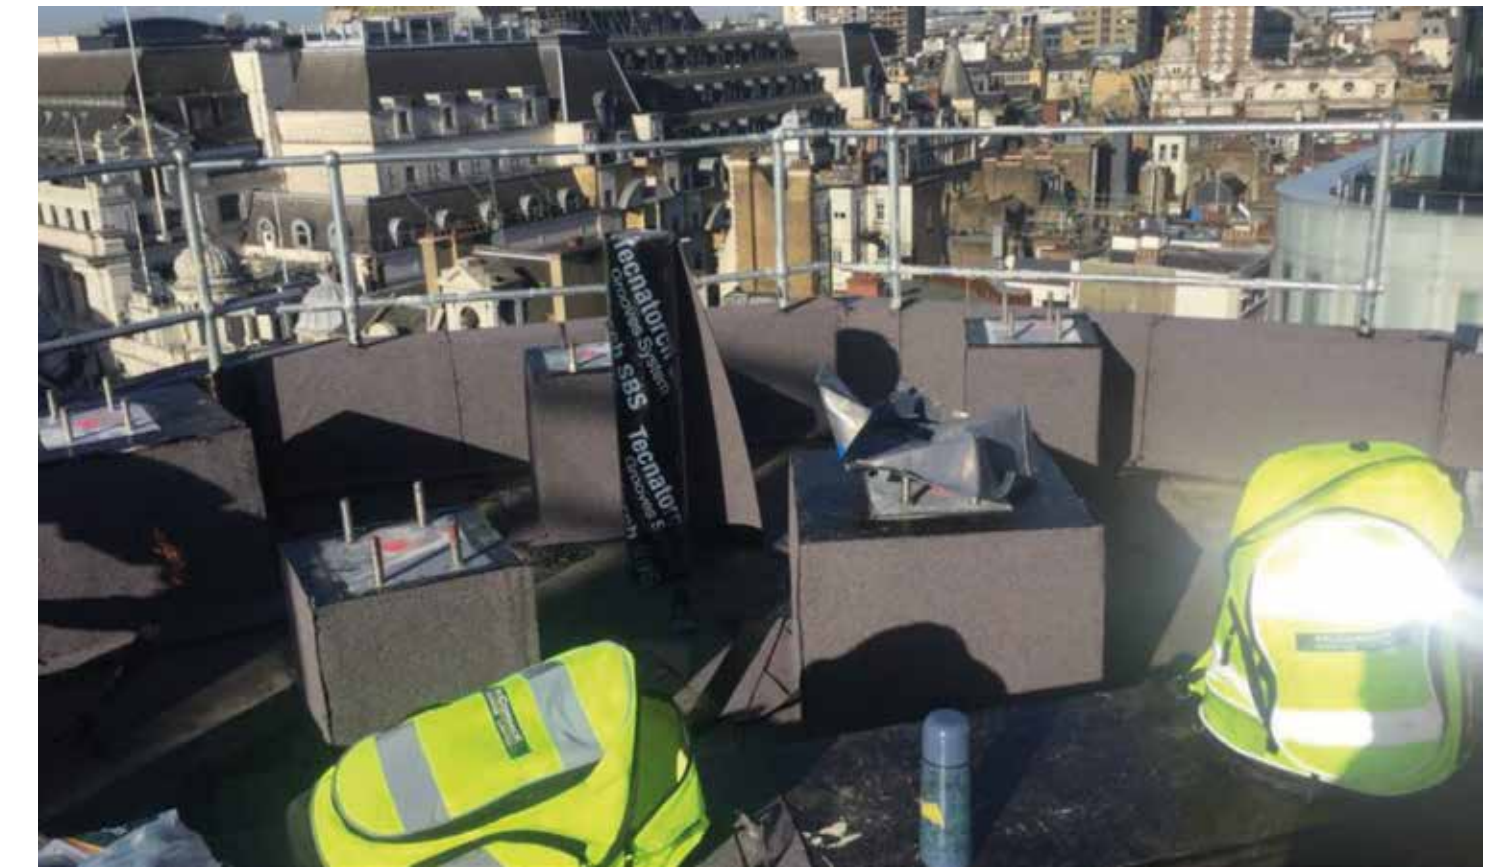
Insulation applied
