HD Bolts Installation & Inspection Procedure

Enhancing Access, Safety & Efficiency
in High-Rise Building Maintenance

IntegralCradles GIND | UK

Recommended Plinth Detail

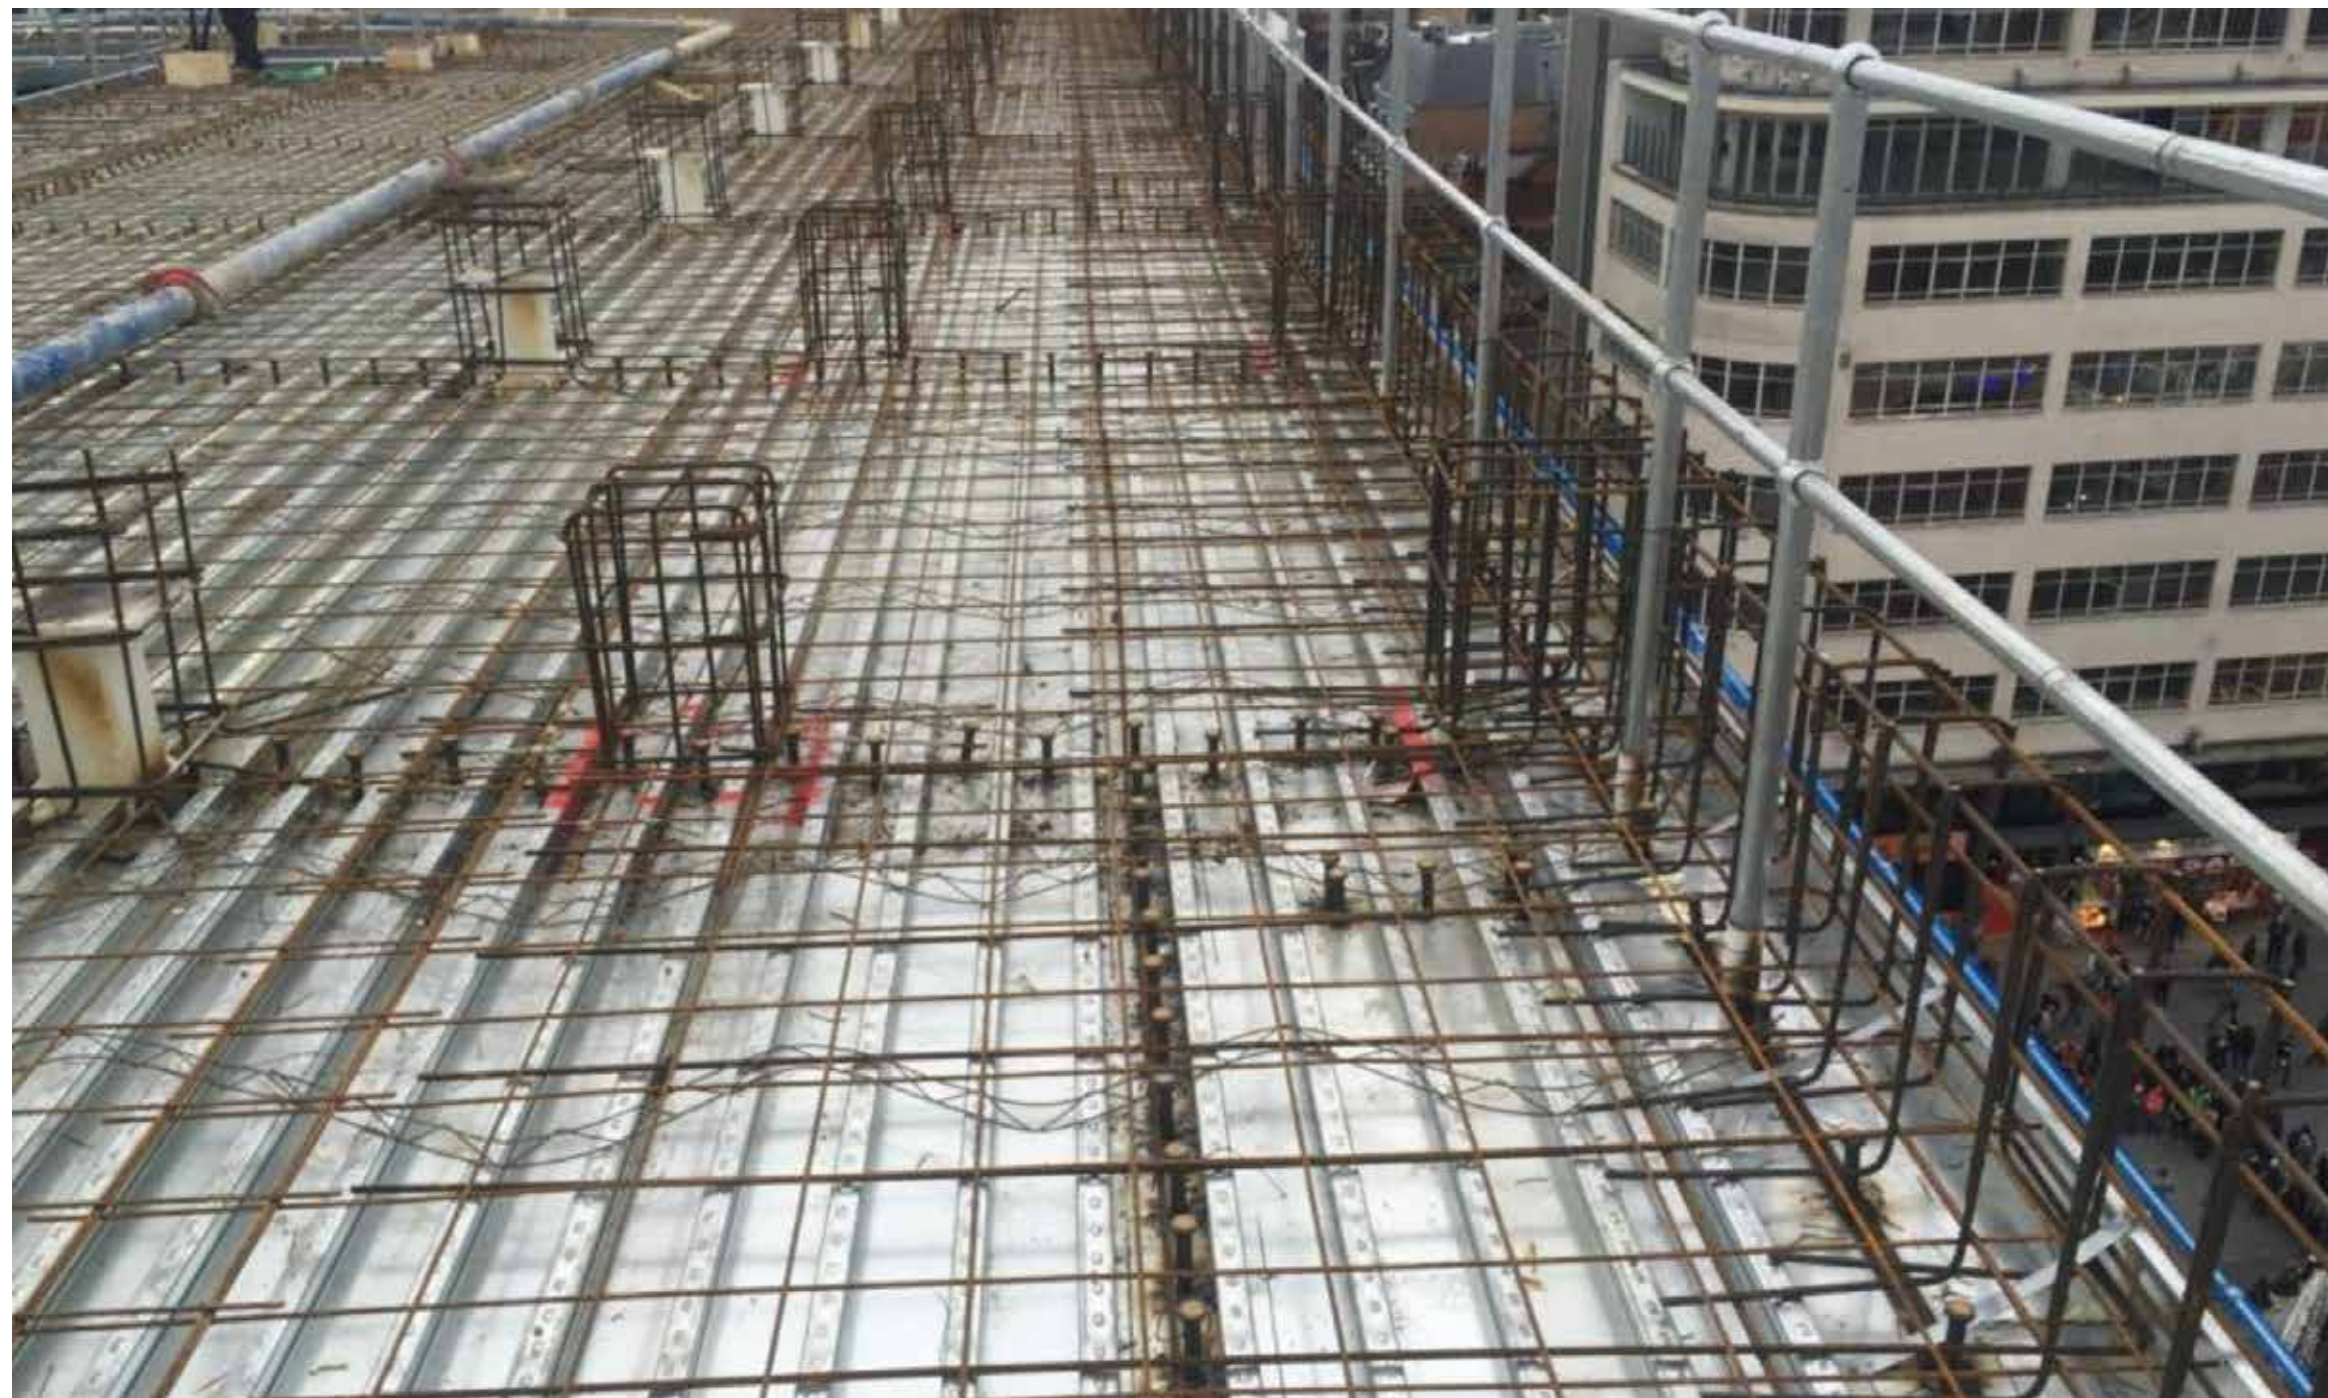
LOLER Inspection carried out

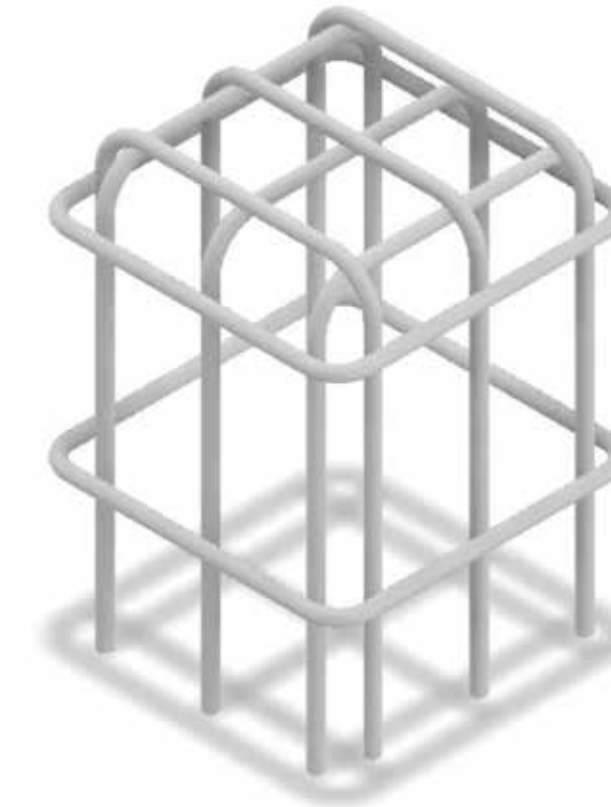
Main slab poured with typical formed upstand starter bars showing

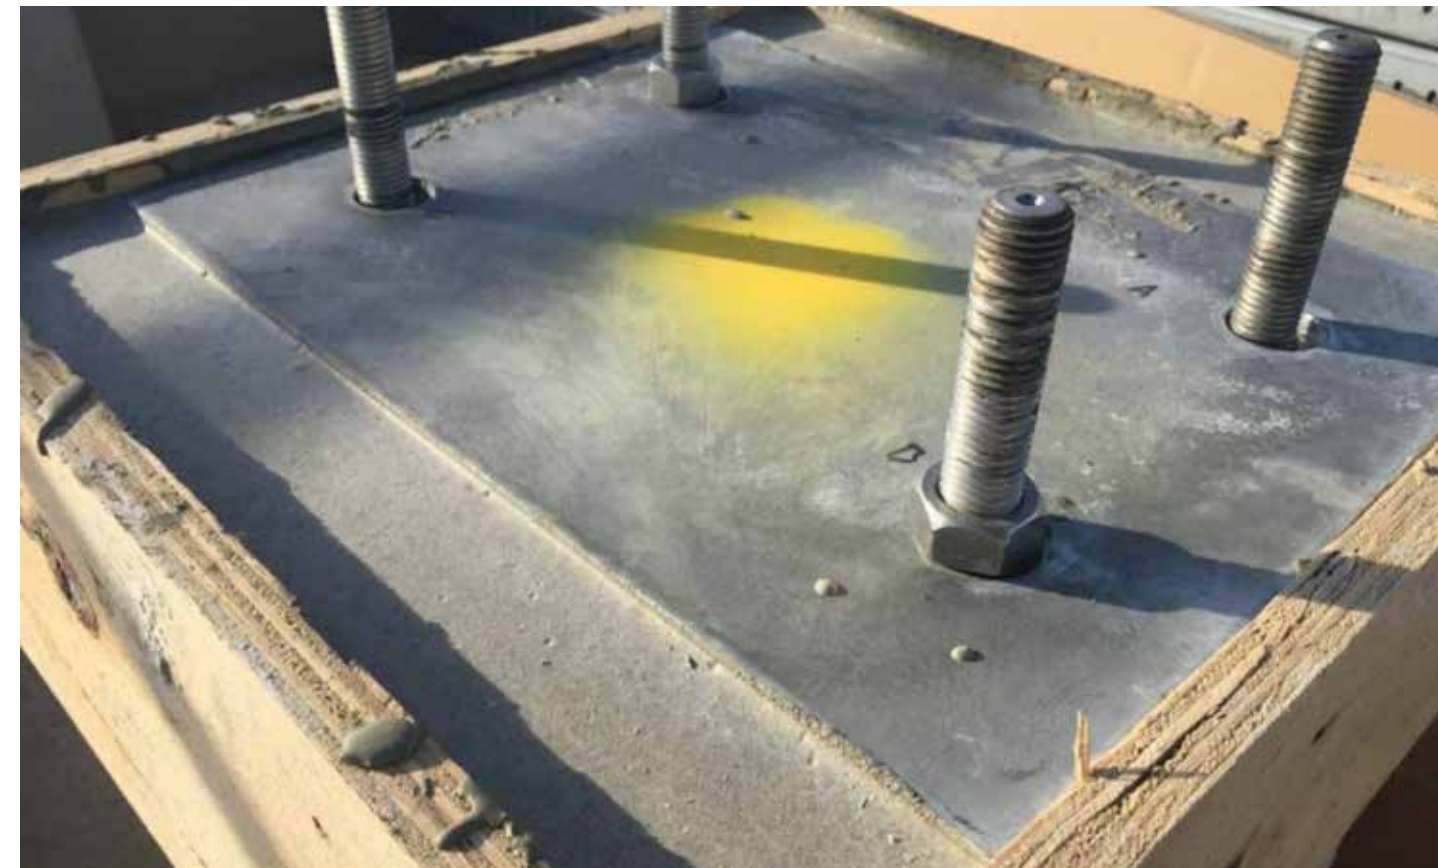
Bed plate installed and grouted in

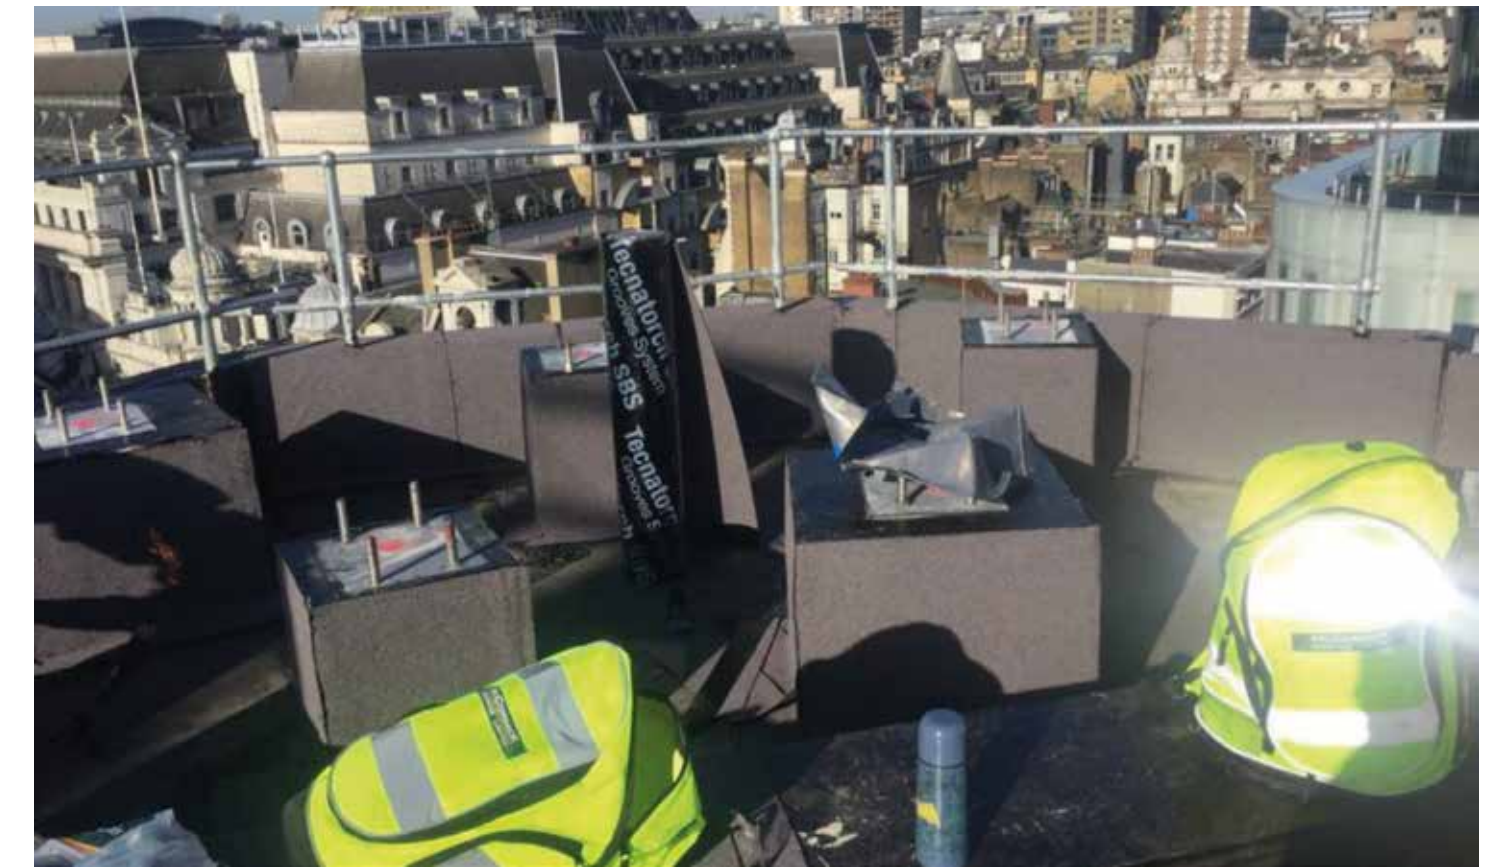
Insulation applied
